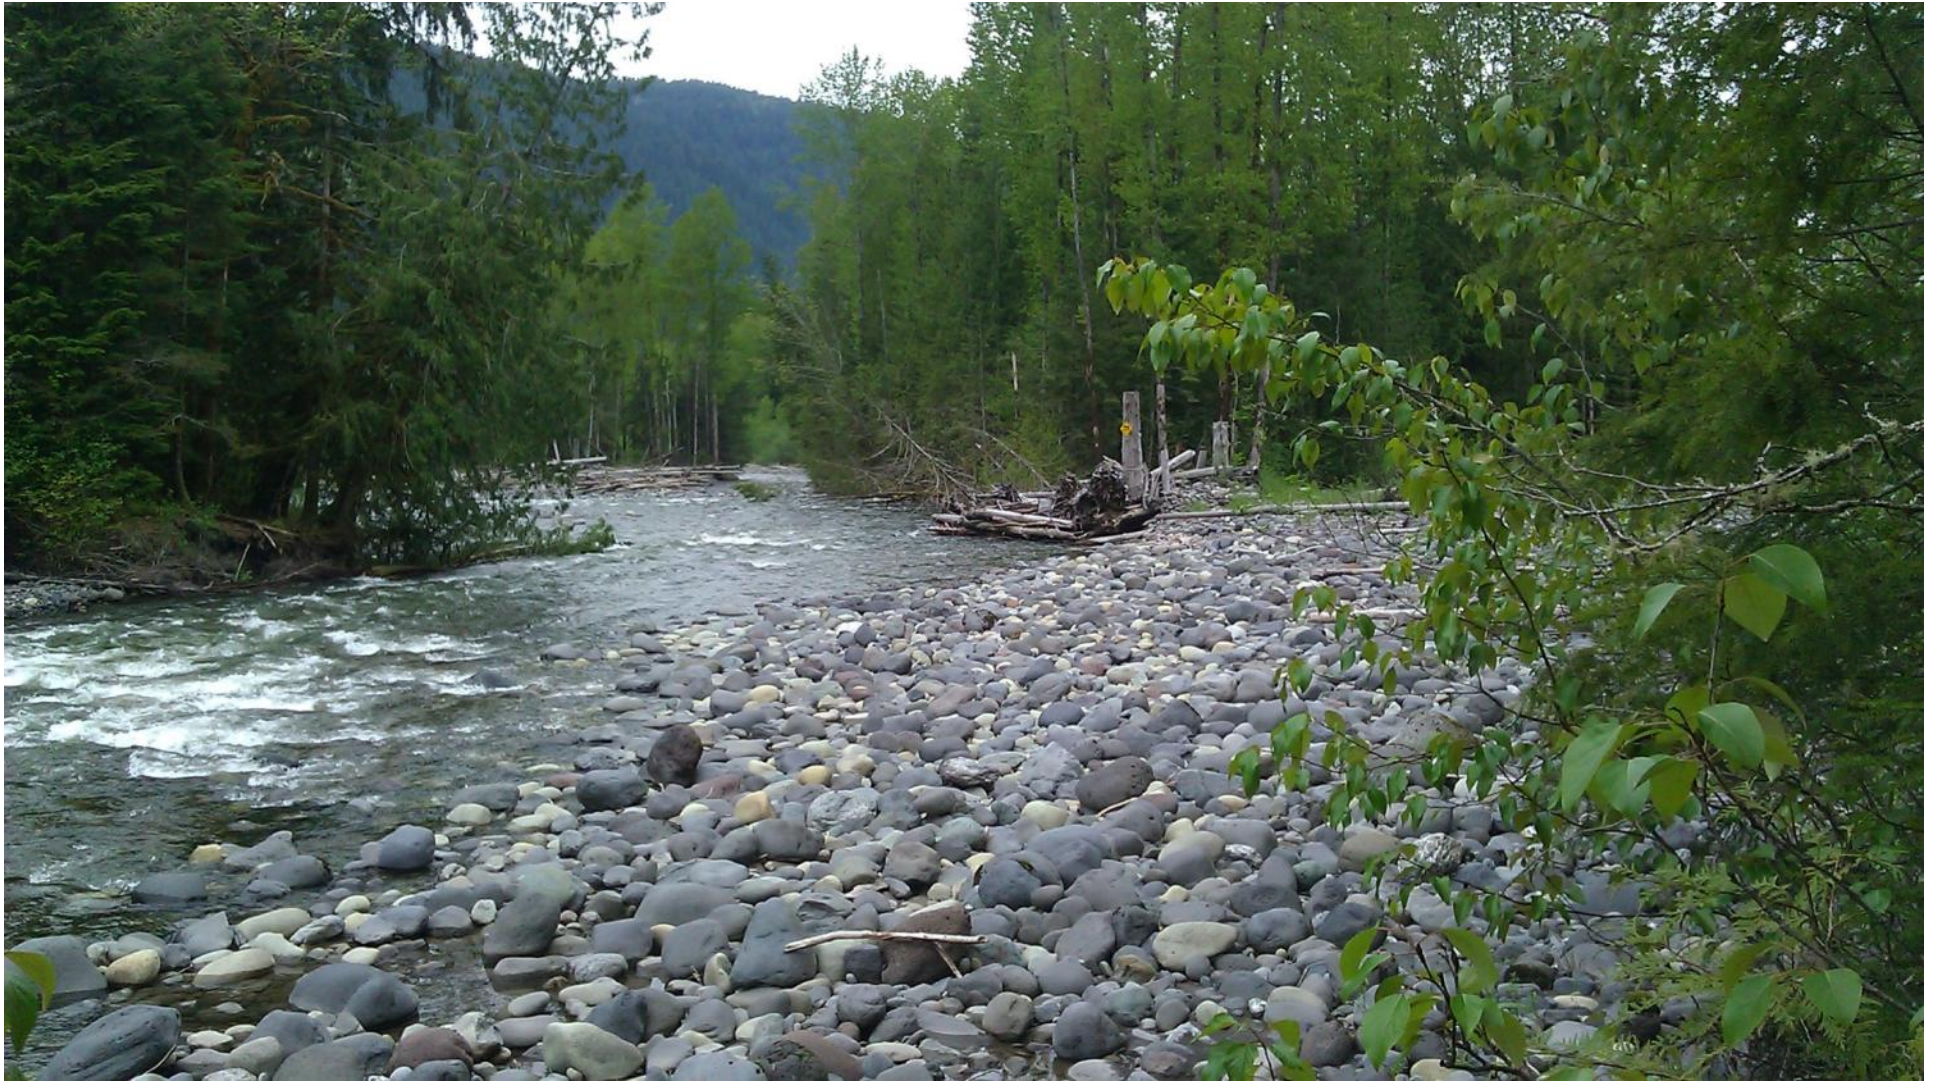
Figure 8A: Incised channel. Image 5/8/2014 from RM 4.9 looking down the incised left channel. Right channel is ~ 5 ft higher than the left channel.

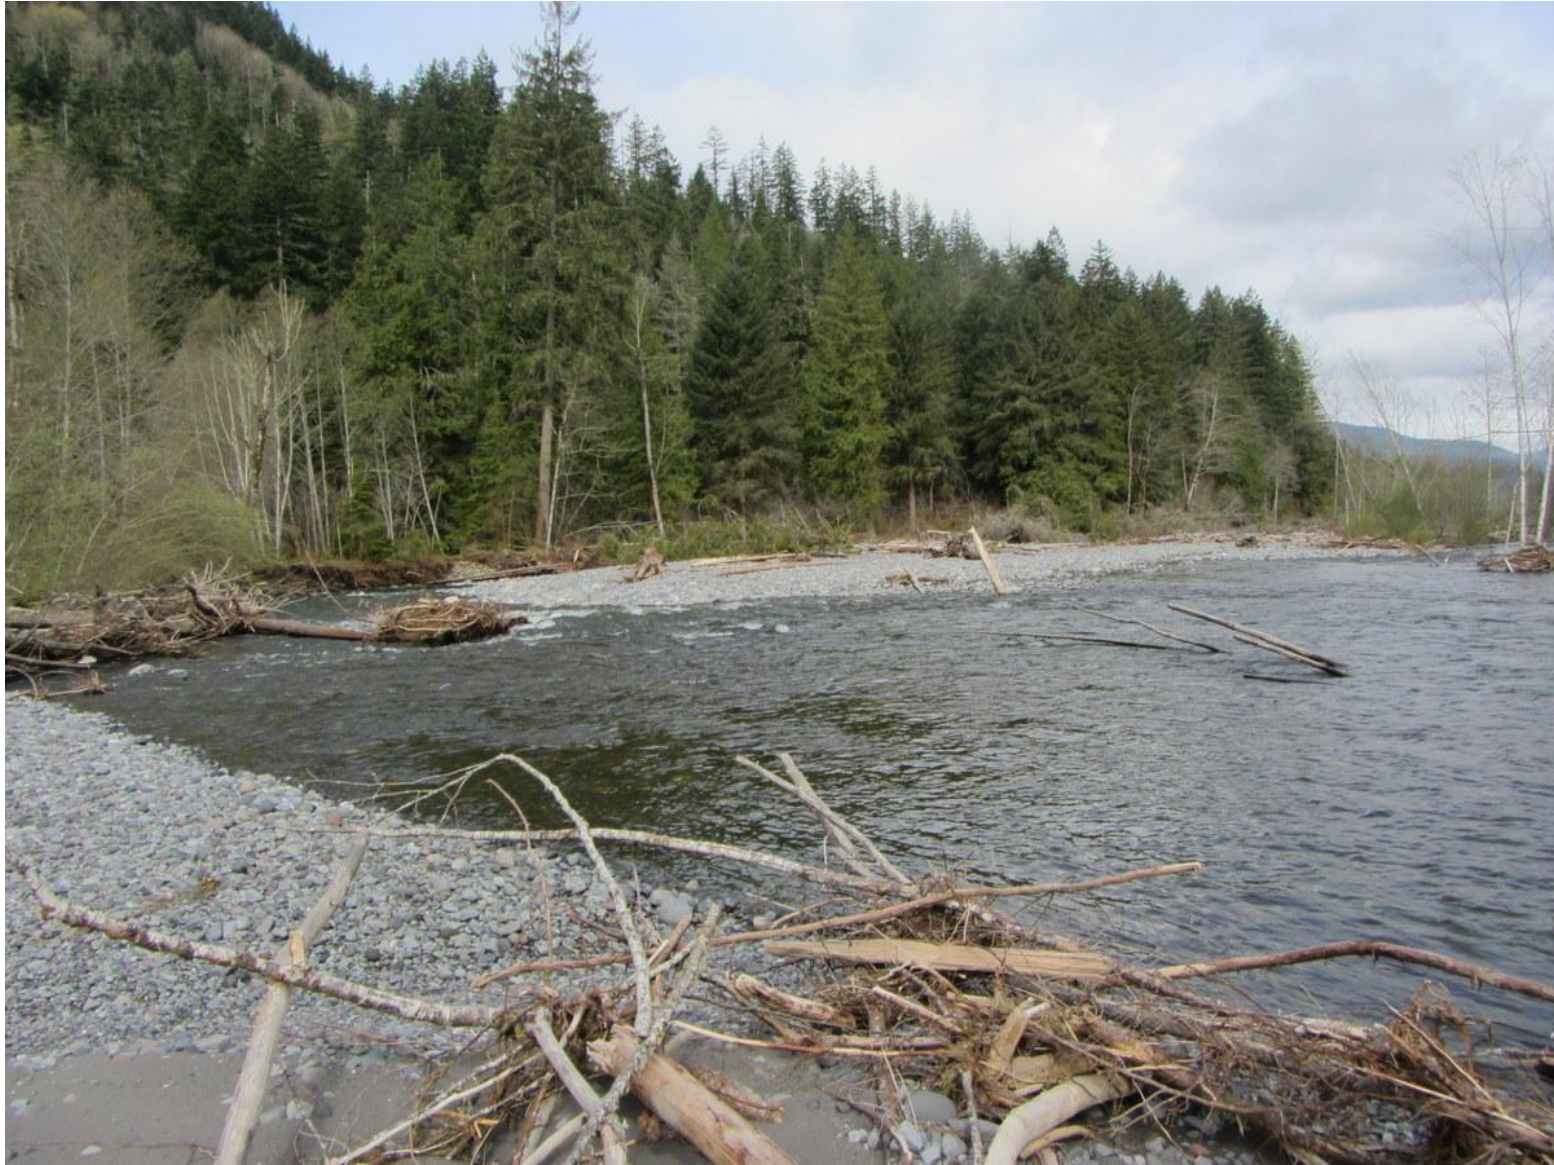
Figure 8B: Recent mid channel bar formation force flow to the banks. Note: Woody debris (left) and mature trees provide cover and pools. Photo taken 4/4/2014 at RM 4.6 looking downstream from the left bank.

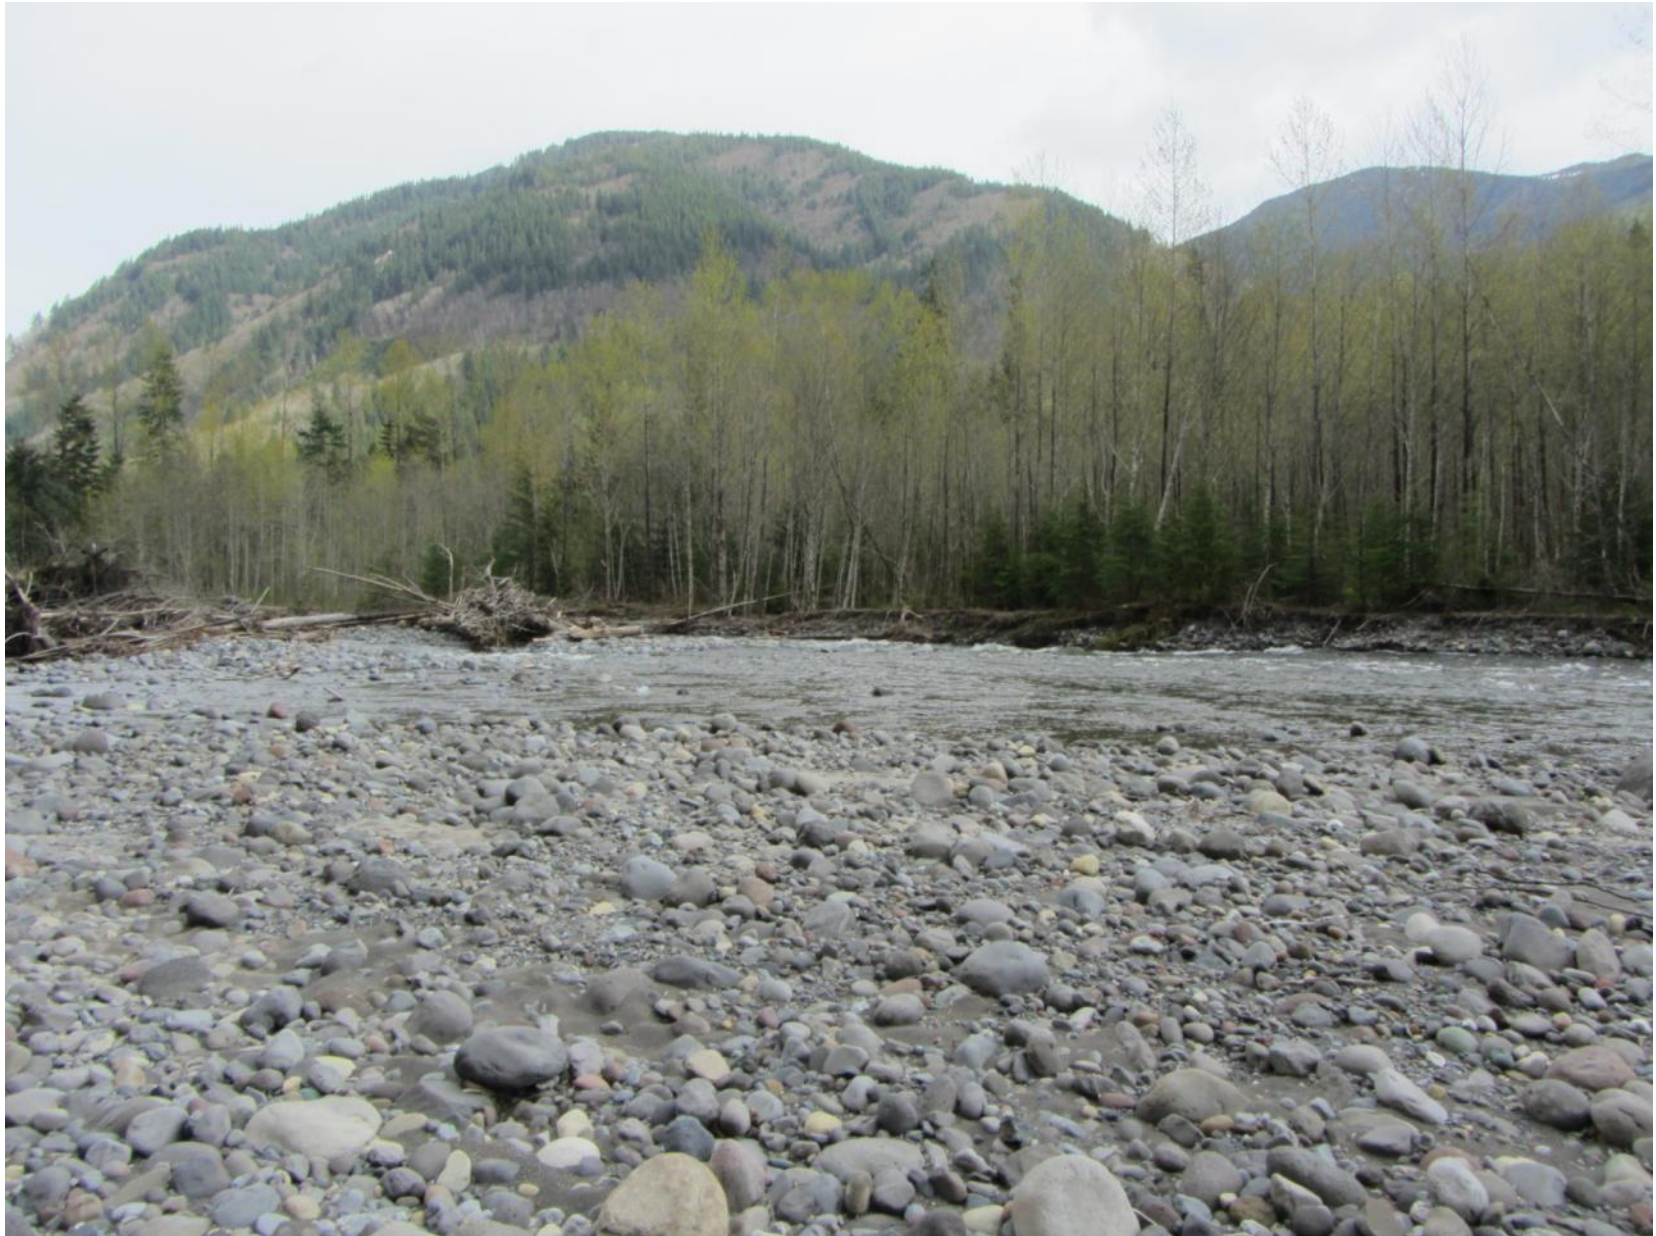
Figure 8C: Image shows wide channel bars, low channel complexity, and immature riparian vegetation that is vulnerable to lateral channel migration. Taken 4/17/2014 at RM 4.2 from the left side of the channel, looking across to the right bank.

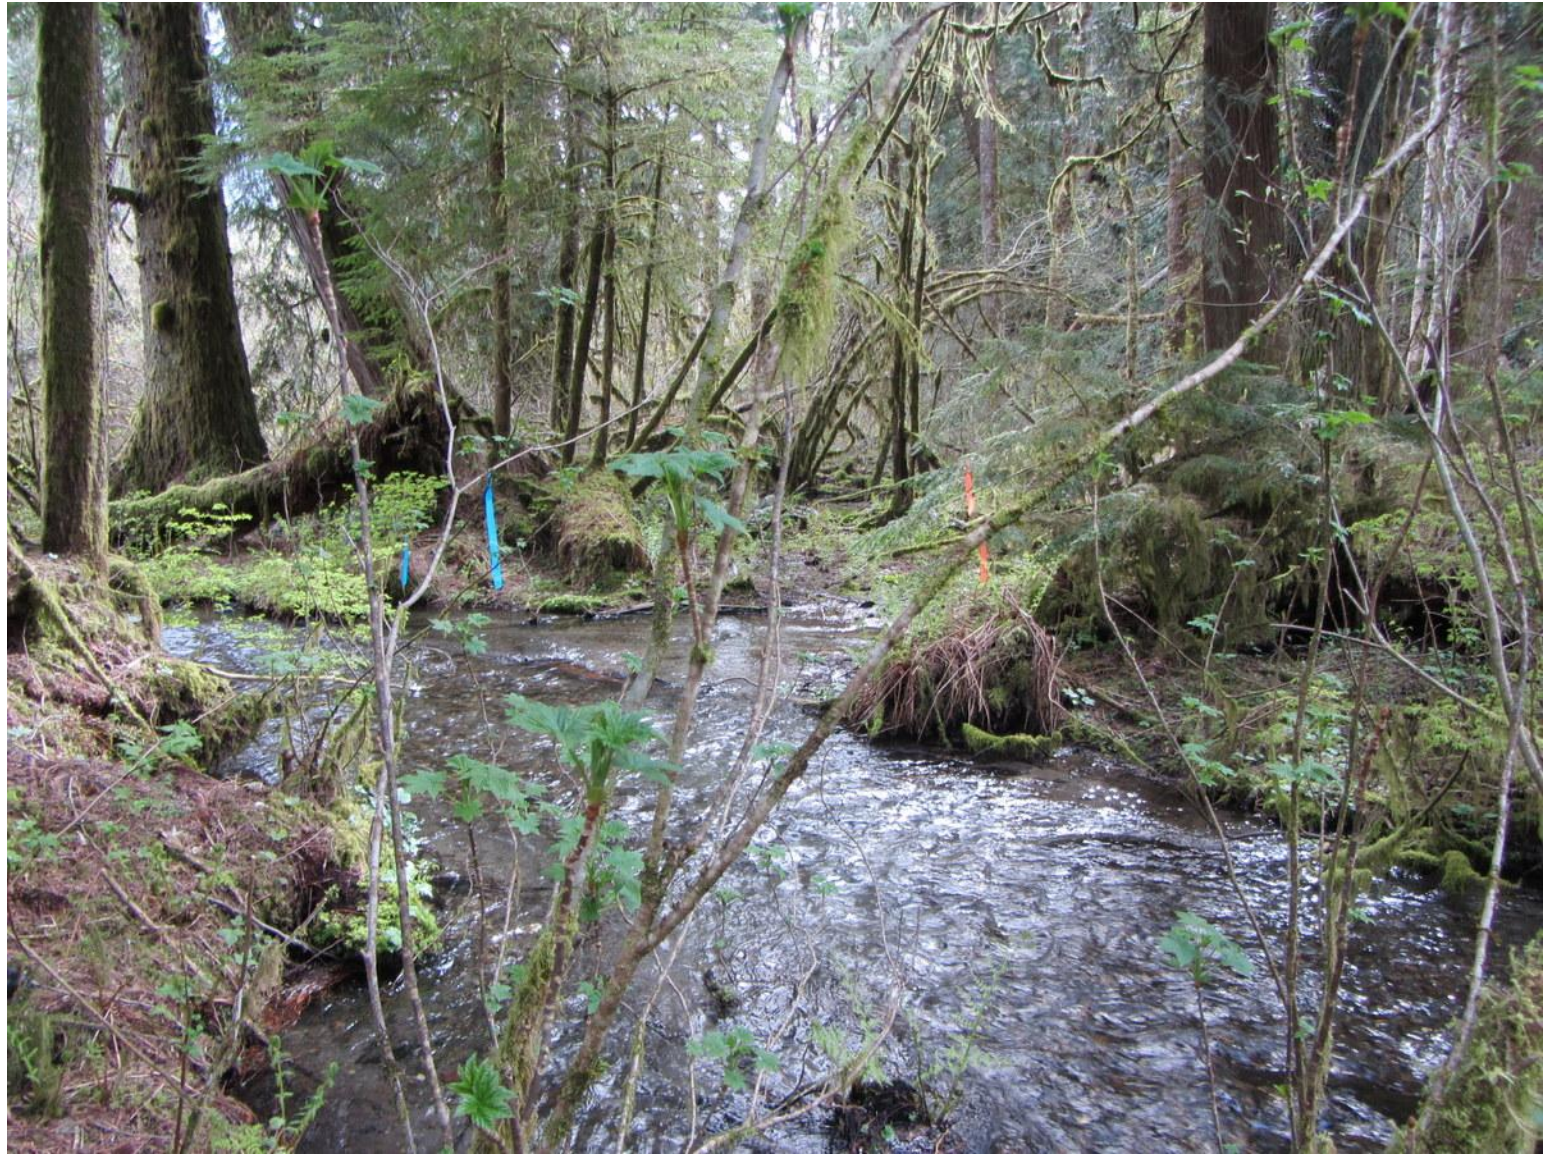
Figure 8D: Bear Creek's alluvial fan with 2013 spawning flagging. Image 4/17/2014, from left bank looking downstream, 0.3 miles upstream from the RM 4.6 on the MFN.

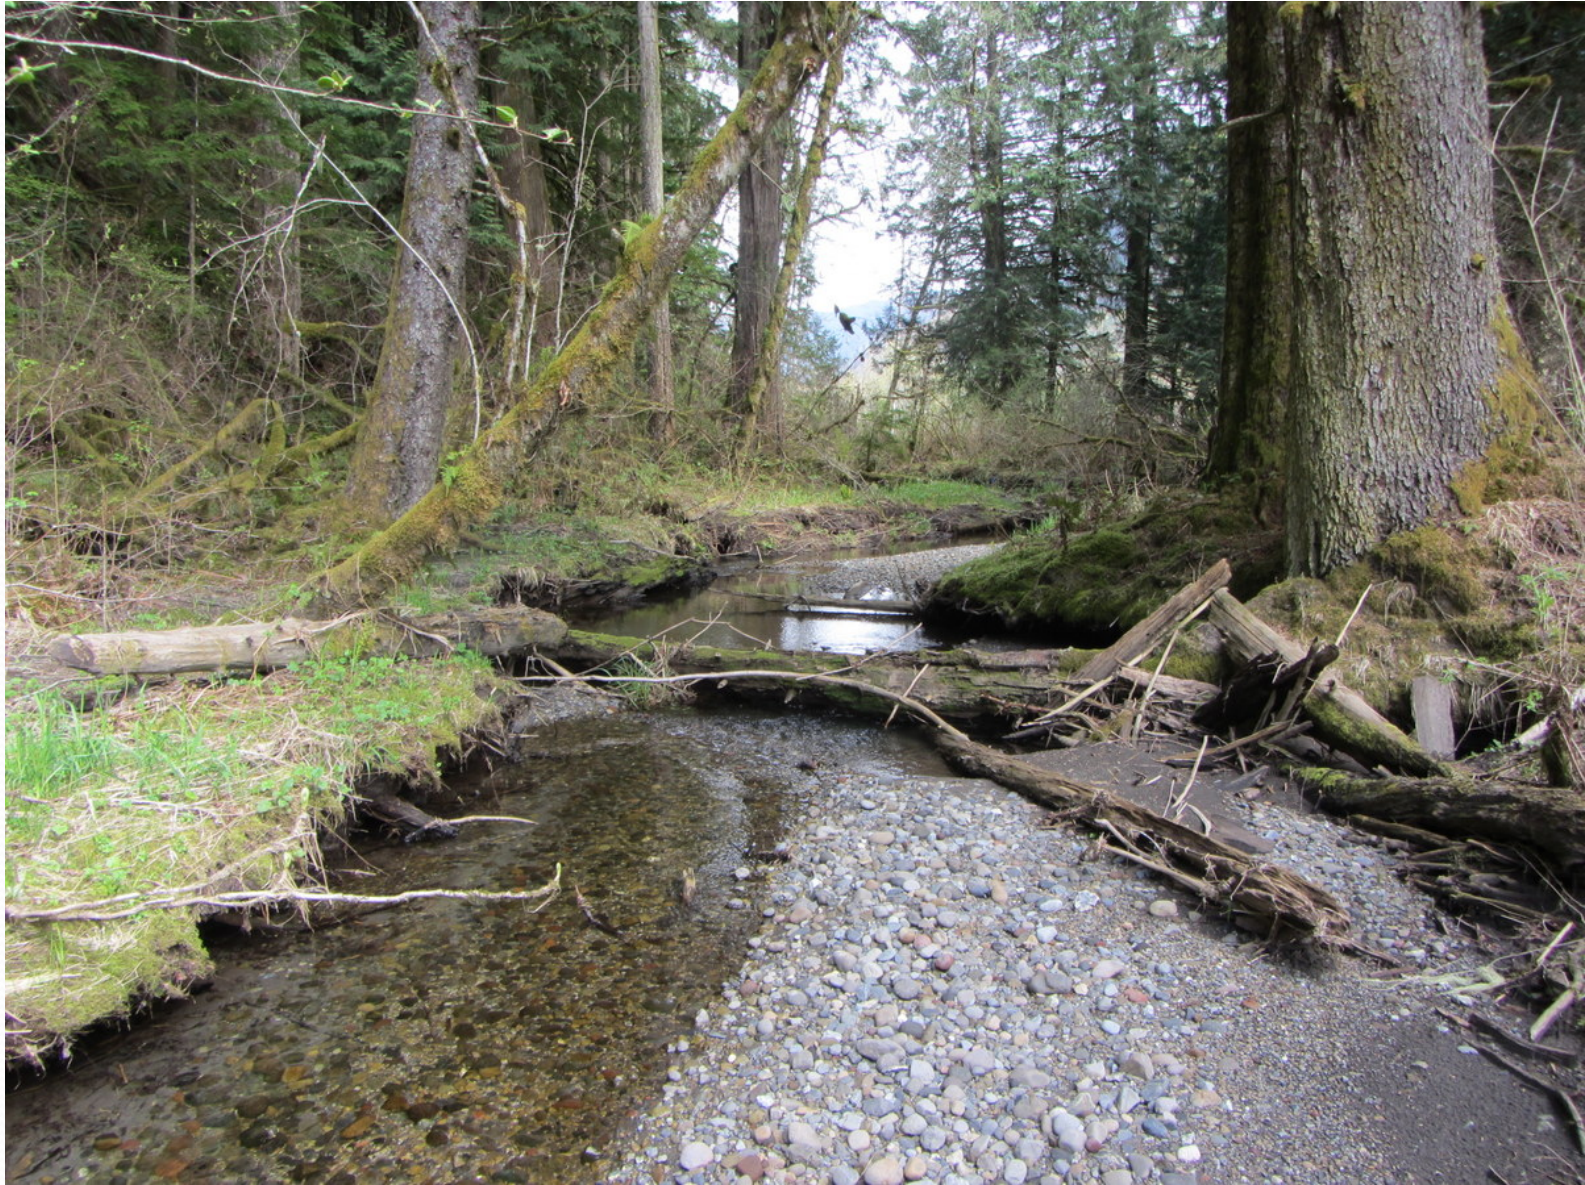
Figure 8E: Bear Creek's side channel, with complex channel form and good cover. Image 4/17/2014, Looking downstream, 0.2 miles downstream from the RM 4.6, a connection with Middle Fork during high flows events.

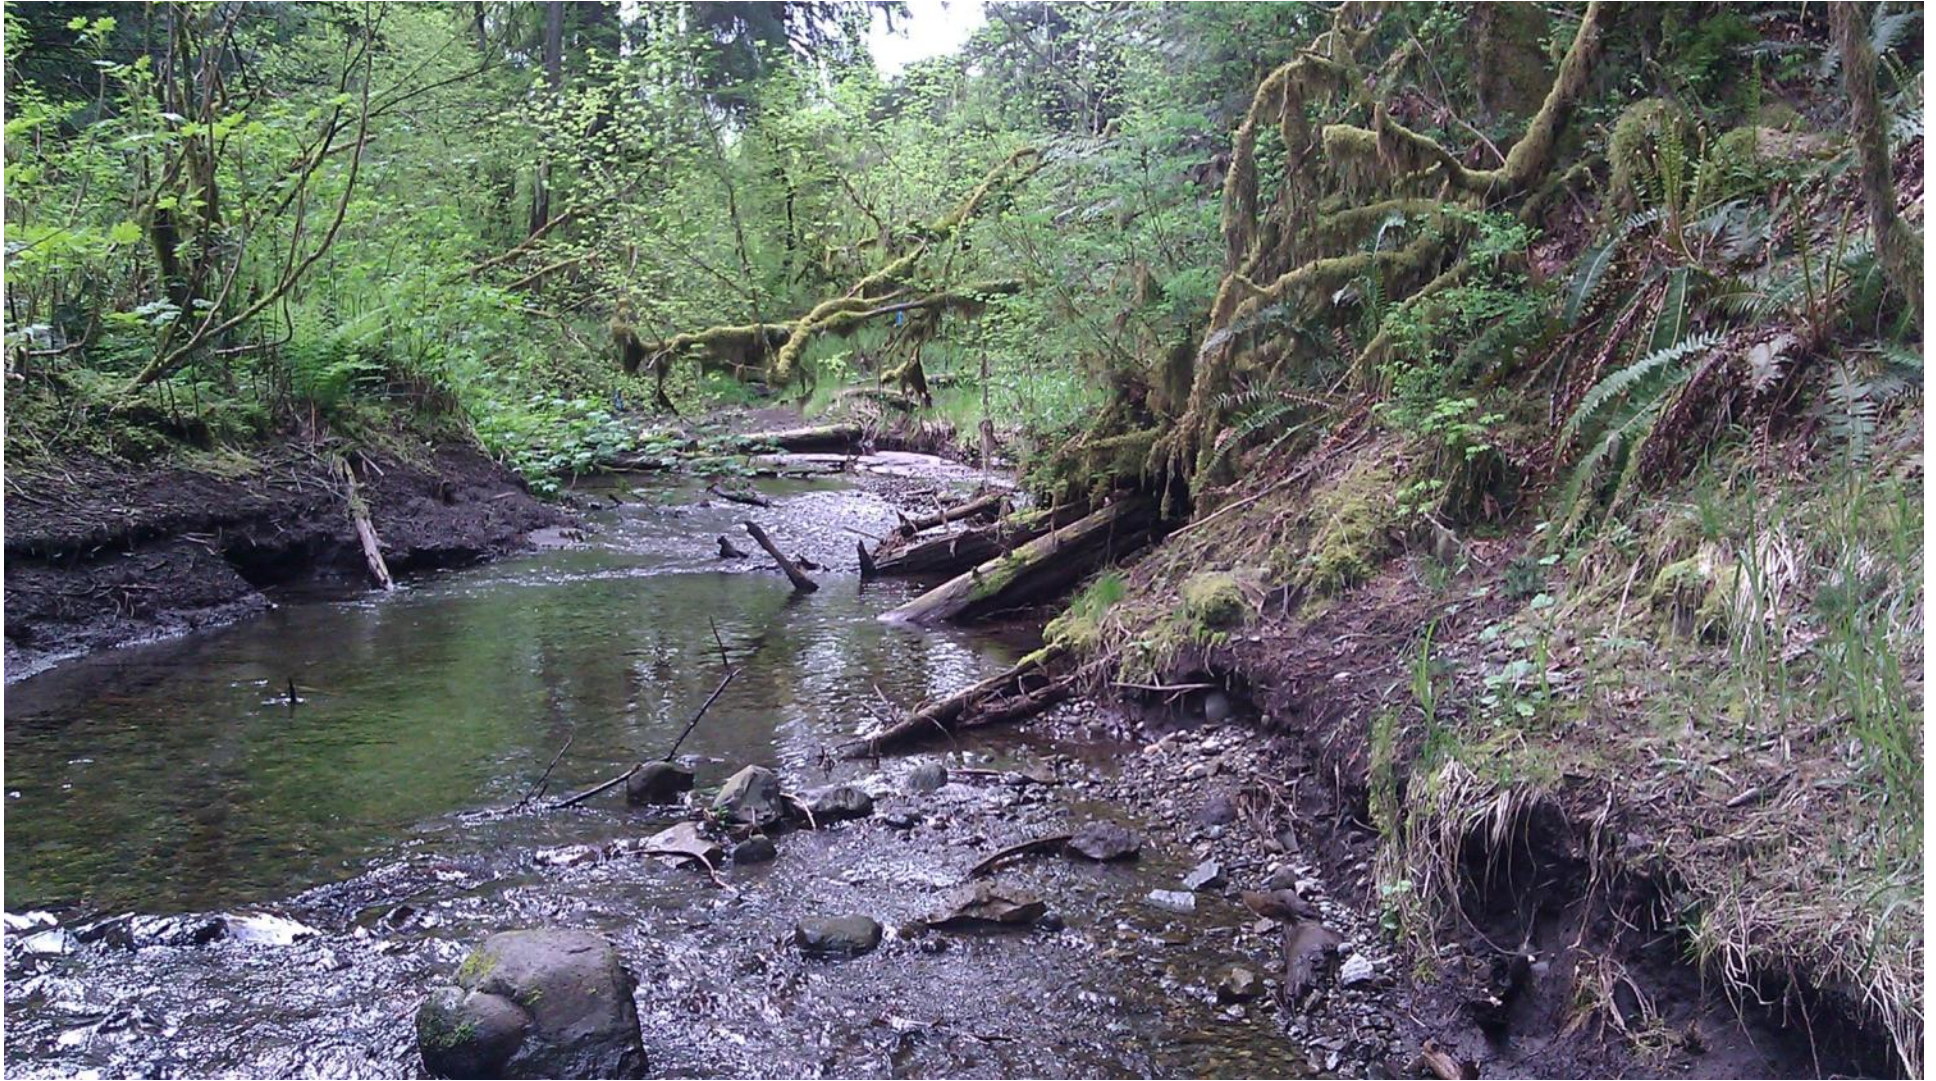
Figure 8F: Bear Creek's side channel, with complex channel form and good cover. Image 4/17/2014, Looking upstream, 0.3 miles downstream from the RM 4.6, a connection with Middle Fork during high flows events.

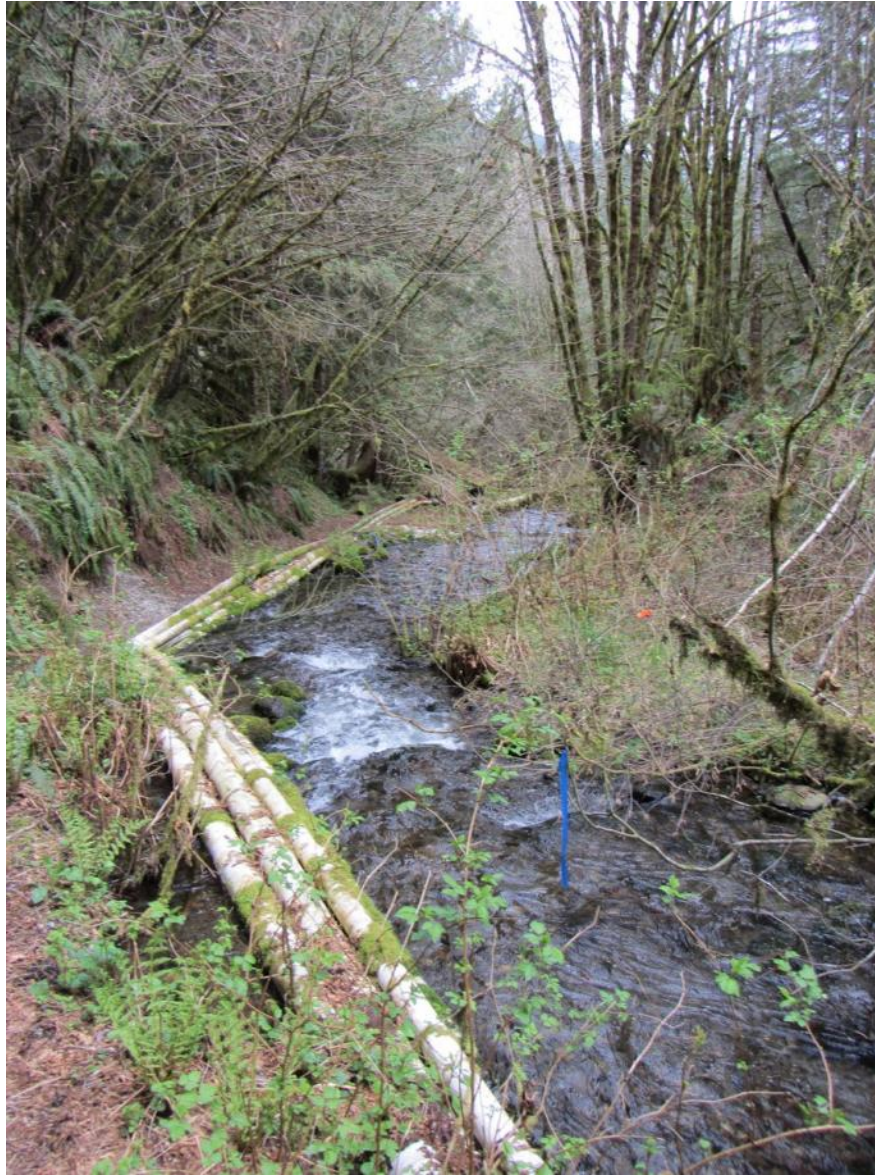
Figure 8G: Peat Bog Creek, 0.2 miles upstream of valley floor. Note: Confined channel with pipe used by WDFW to supply a steelhead acclimation ponds and 2013 spawner survey flags. Image 4/17/2014, looking downstream from the left bank.

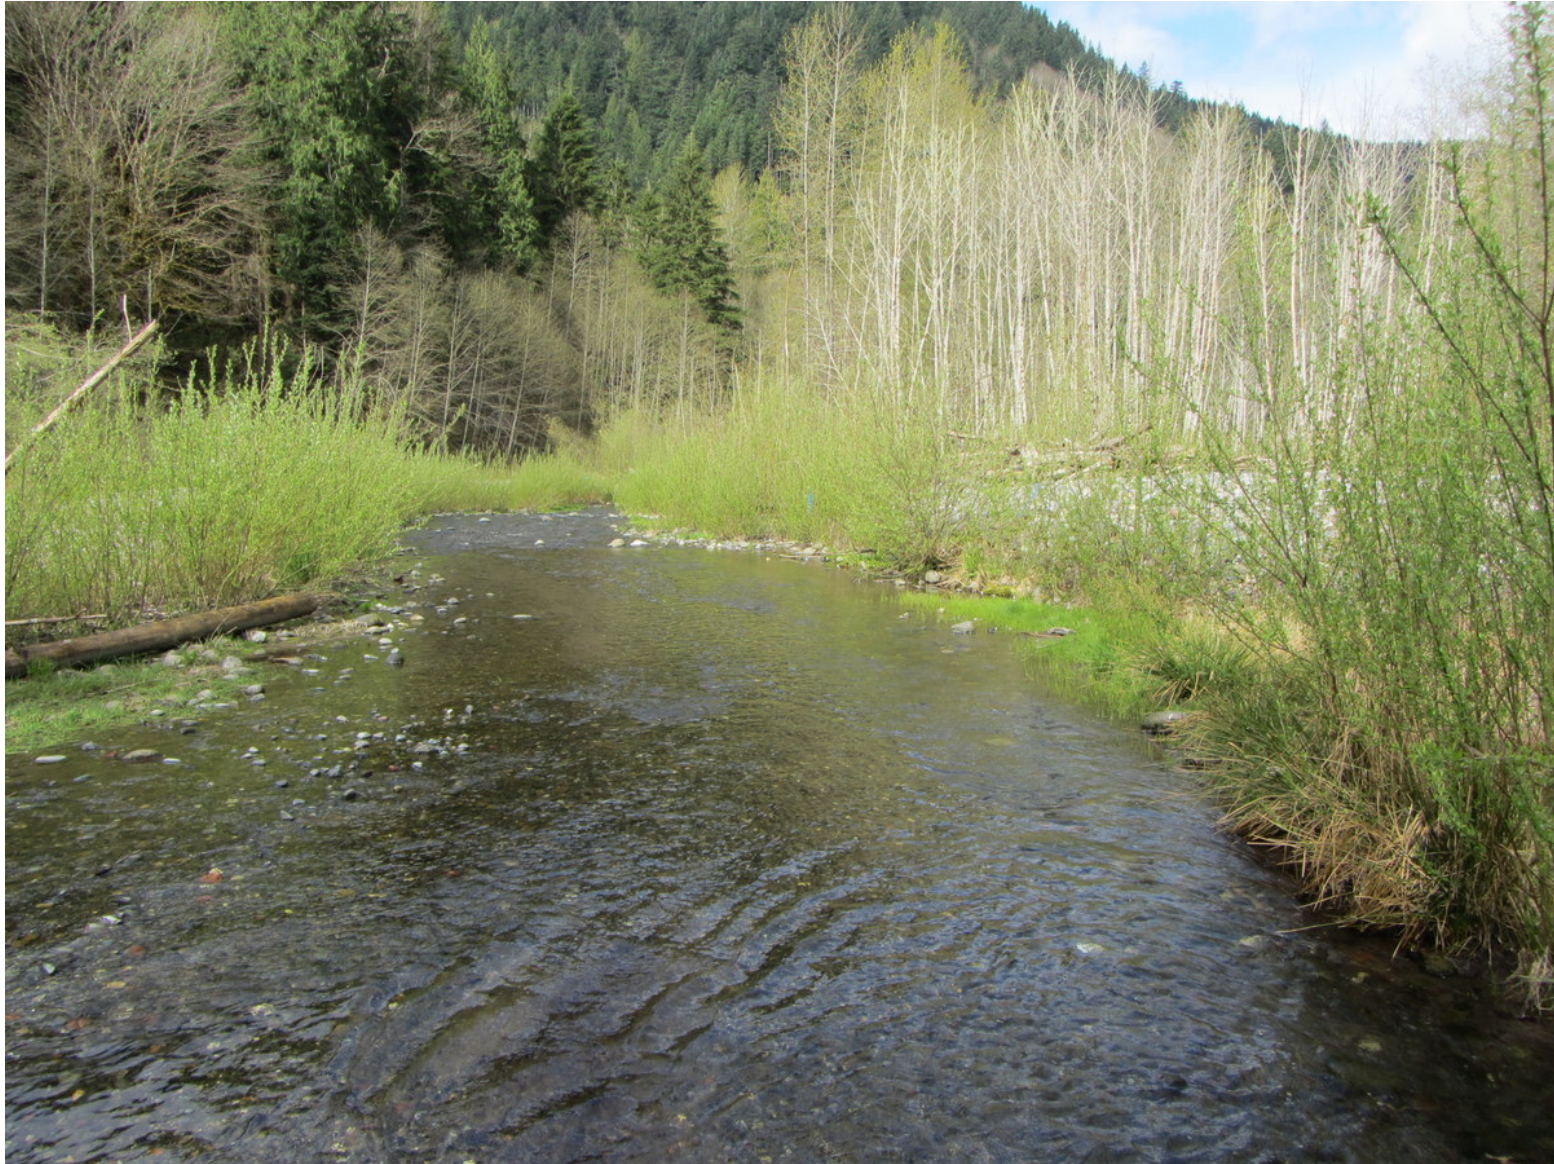
Figure 8H: Peat Bog Creek, flowing down the middle of an abandoned 180-foot wide channel scar of the Middle Fork. Note: the low channel complexity. Image 4/17/2014, Looking downstream mid channel, 0.2 miles upstream of the mouth with the MFN.
